INVESTIGATION AND REPORT INTO THE DEATH OF

<sup>G</sup>  
HAND GLIDER PILOT LEONARD MULLINS ON SUNDAY

JULY 15th 1984.

<sup>G</sup>  
OF THE IRISH HAND GLIDING ASSOCIATION.

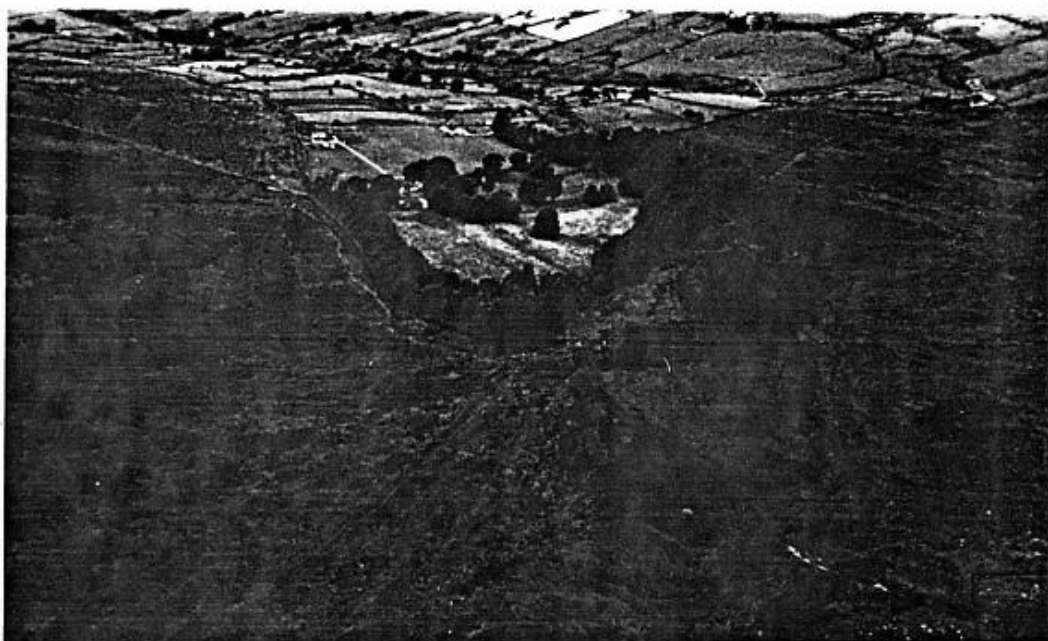
Aerial view  
looking N/W  
from Black Hill.  
Impact site is on  
extreme bottom  
right.

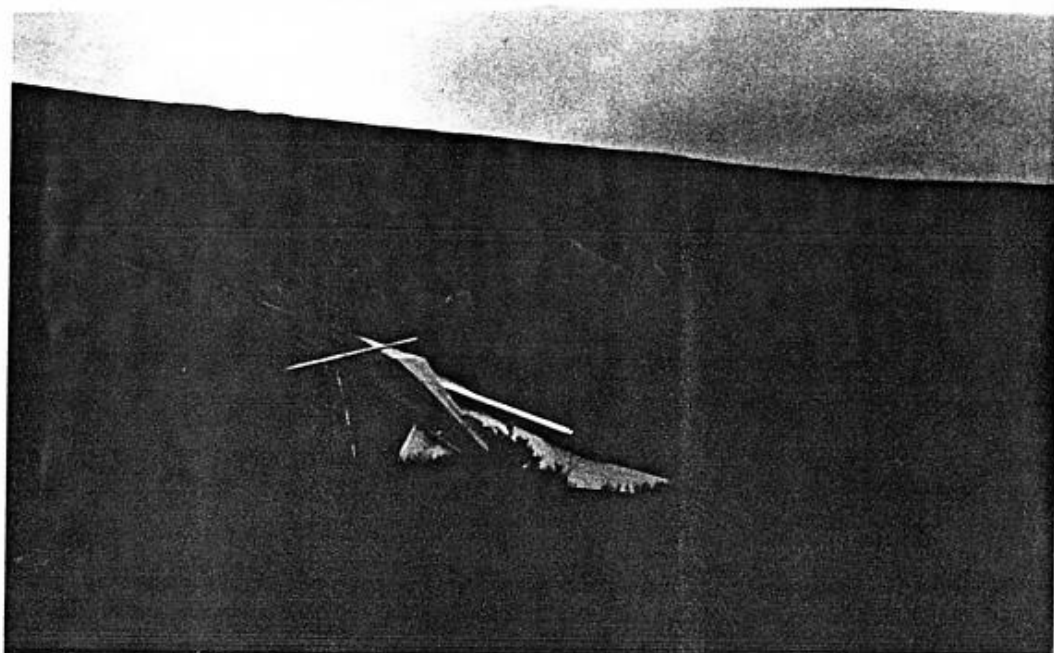
Photograph  
showing glider  
pointing towards  
T/O point.

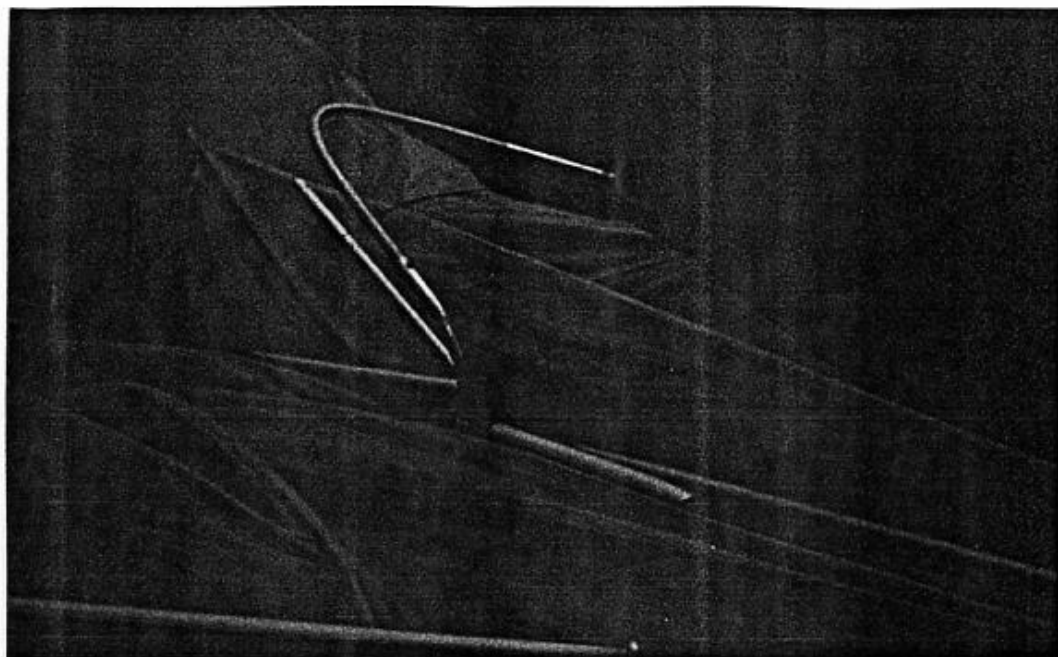
1. Glider's left upright tube bent through 80 degrees at centre. Glider's right upright tube 20 degrees bent at centre and clearly broken off at top. Bottom control bar bent 10 degrees at centre.
2. Glider's left cross boom broken. Glider's right cross boom intact.
3. Glider's keel 10 degrees bent to left at front of glider.
4. Glider's two leading edges intact.
5. Glider's king post intact, but sprung through aperture and found beneath sail. The pivot nut severely bent, but the keel is not compressed.
6. Top rigging intact.
7. Bottom rigging intact.
8. Sail intact.
9. Batons intact but had obviously been repaired at some stage.

Photograph showing  
pilot's left upright  
bent through 80°.

This picture was  
taken at the impact  
site before the  
light failed.

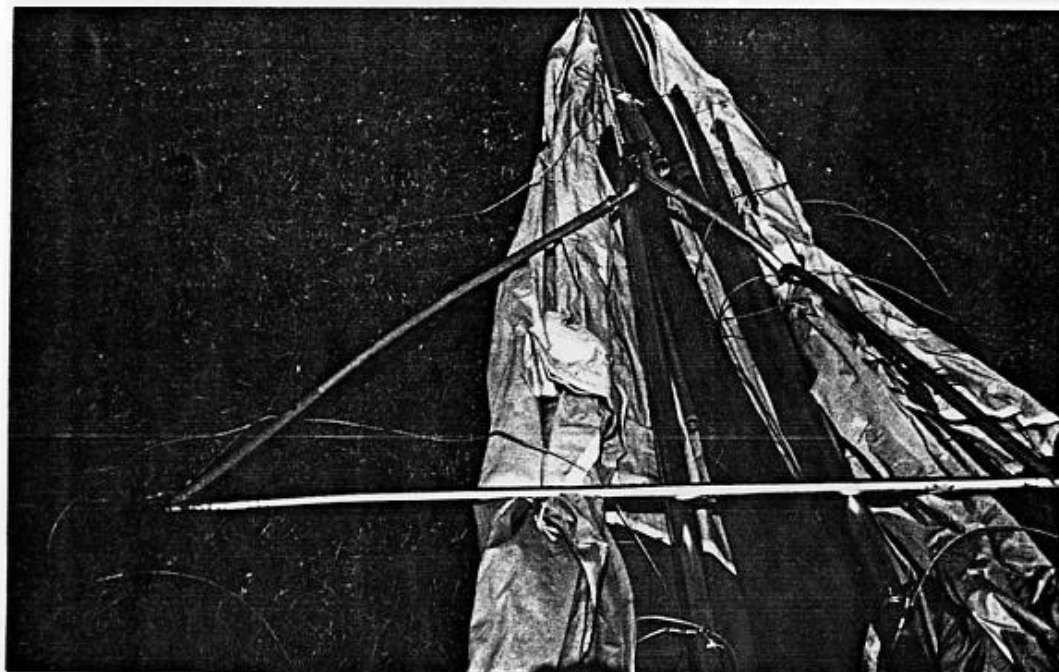
Entire control  
frame assembled.

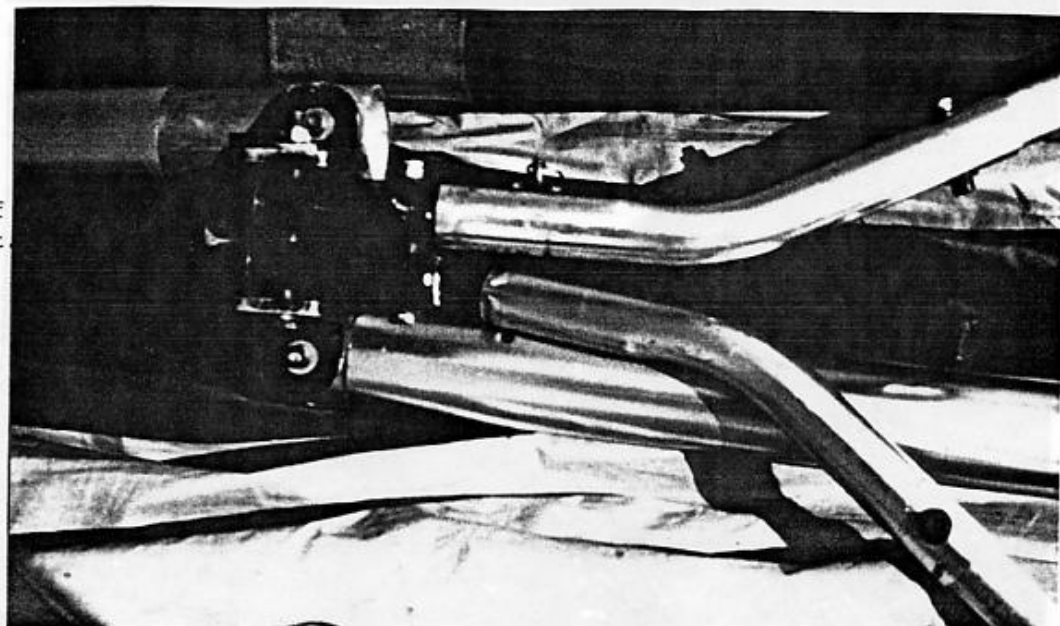
Photograph showing  
clean break at top of  
pilot's right upright.

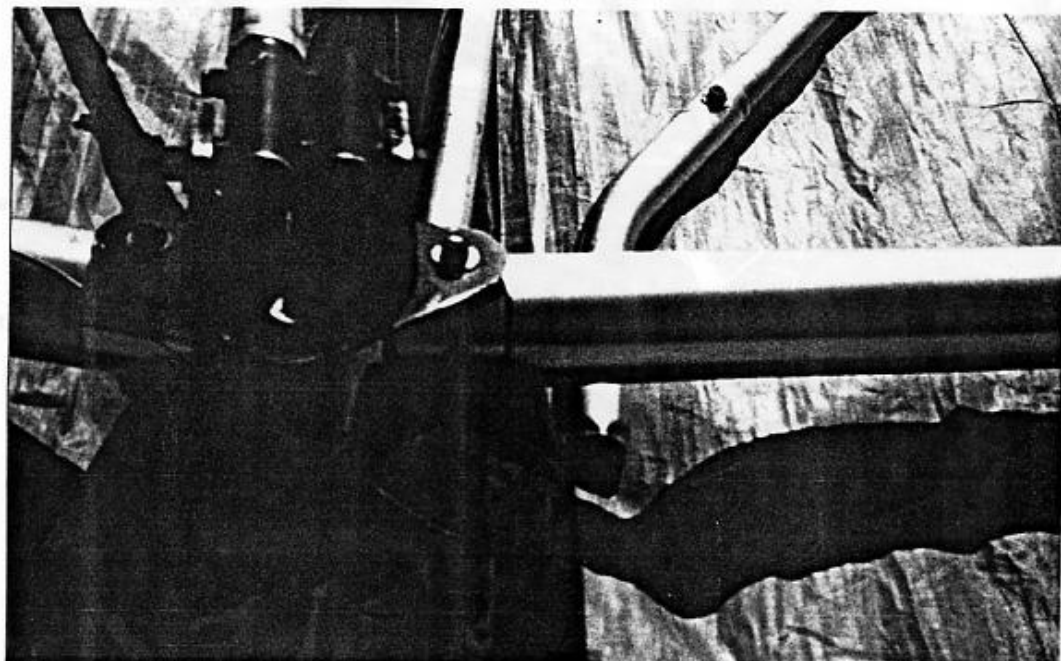
# Centre Assembly

The fracture points indicate the glider's left side impacted first, probably on the corner of the control frame. It would seem likely that immediately after impact the glider "ground looped" (turned upside down) hence forcing the king post through the sail aperture. It would also seem likely that a second ground loop occurred as the glider was found facing up hill and out of wind.

showing ring post  
protruding a distance  
of 1/4 inch.

Note that center bolt  
on which the ring post  
normally rests.

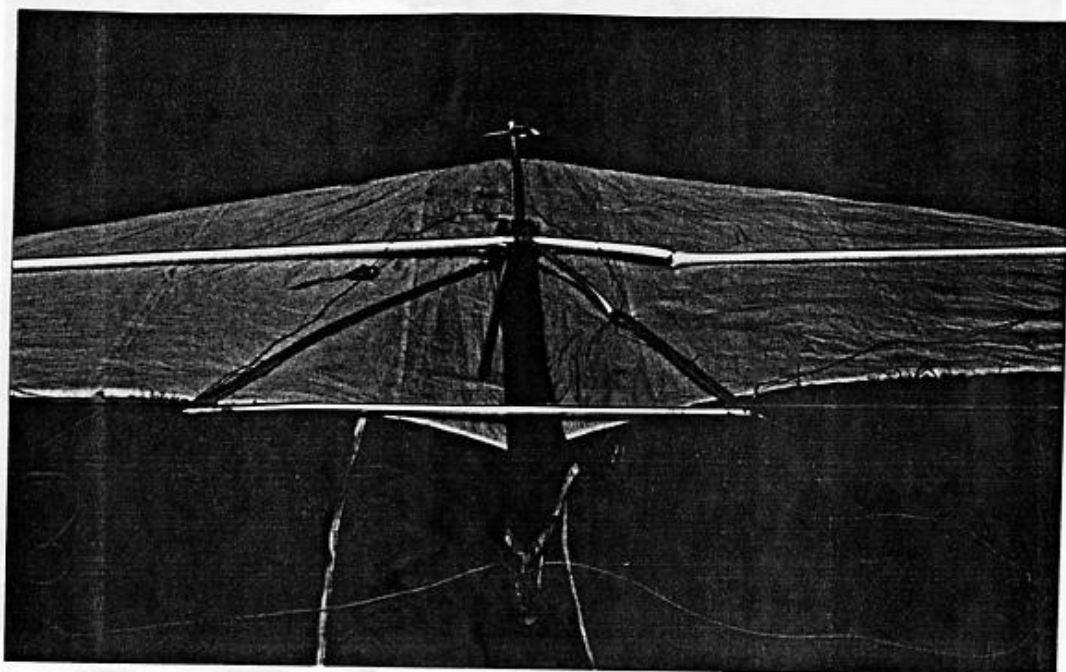
Glider assembled  
upside down showing  
broken cross tube  
(boom) on pilot's  
left.

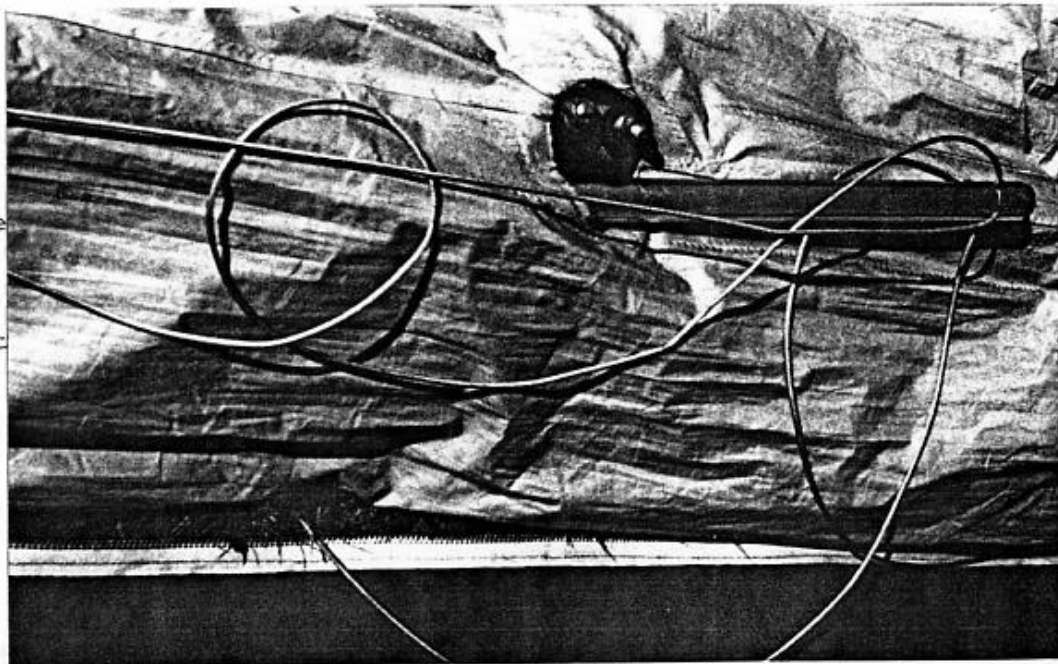
Top photograph  
showing king post  
protruding to underside  
of glider.

Note bent centre bolt  
on which the king post  
normally rests.

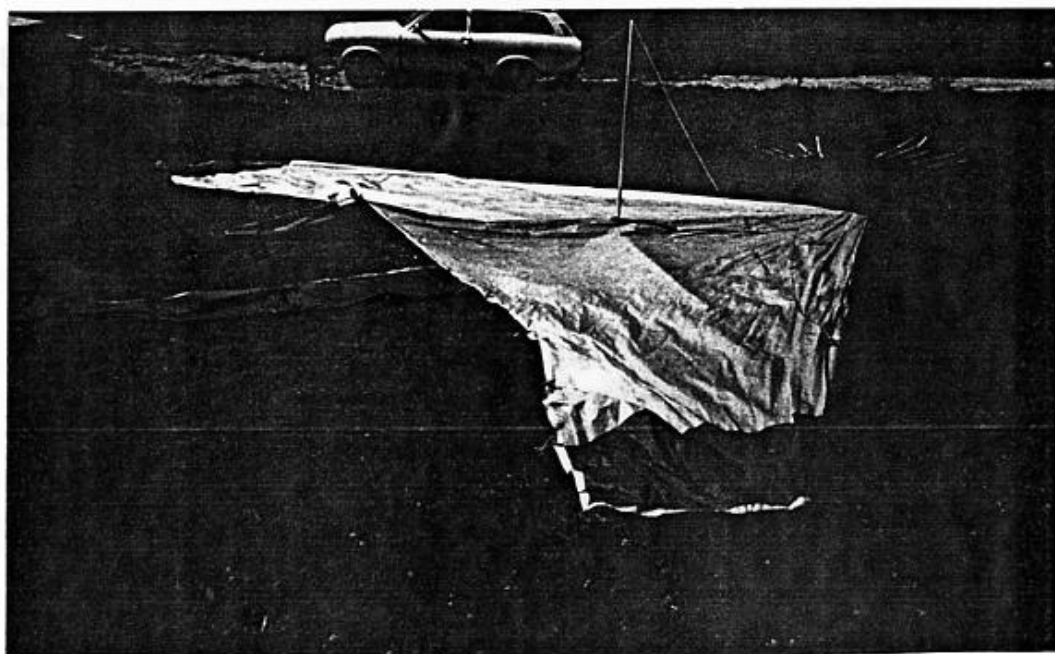
Top view of glider  
showing top rigging  
intact.

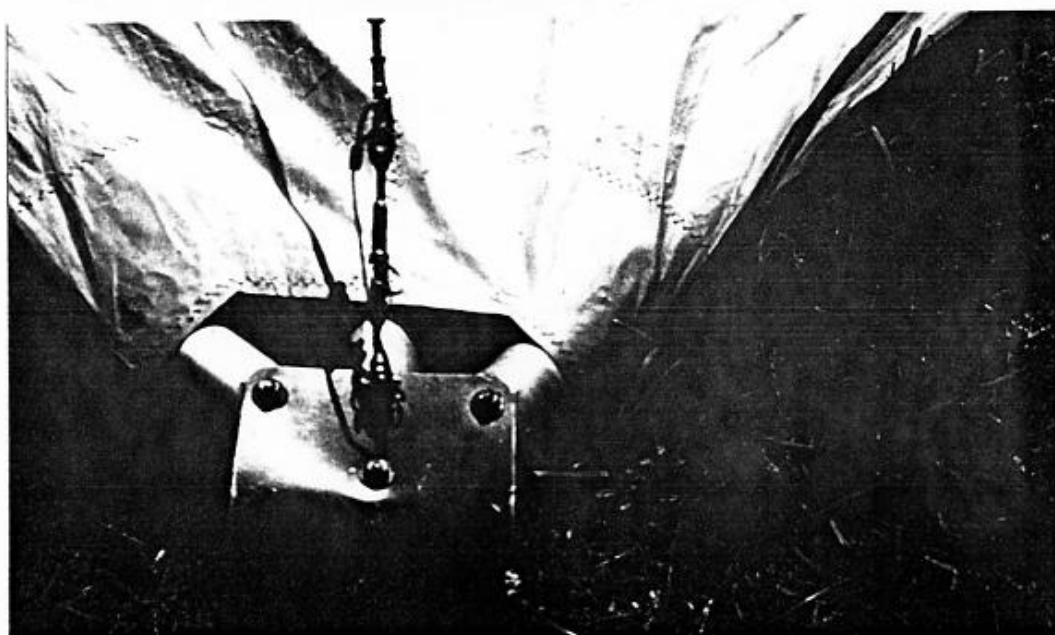
Nose assembly  
from top.
