INVESTIGATION INTO A HANG GLIDING ACCIDENT AT ST. MULLIN'S,  
CO. CARLOW, DURING THE 1984 CELTIC CUP, WHICH RESULTED IN  
THE SERIOUS INJURY OF PAT MOLLOY.

INFORMATION GATHERED AND REPORT COMPILED BY T.J. GEARY  
& I.W. KIRKER OF THE IRISH HANG GLIDING ASSOCIATION.

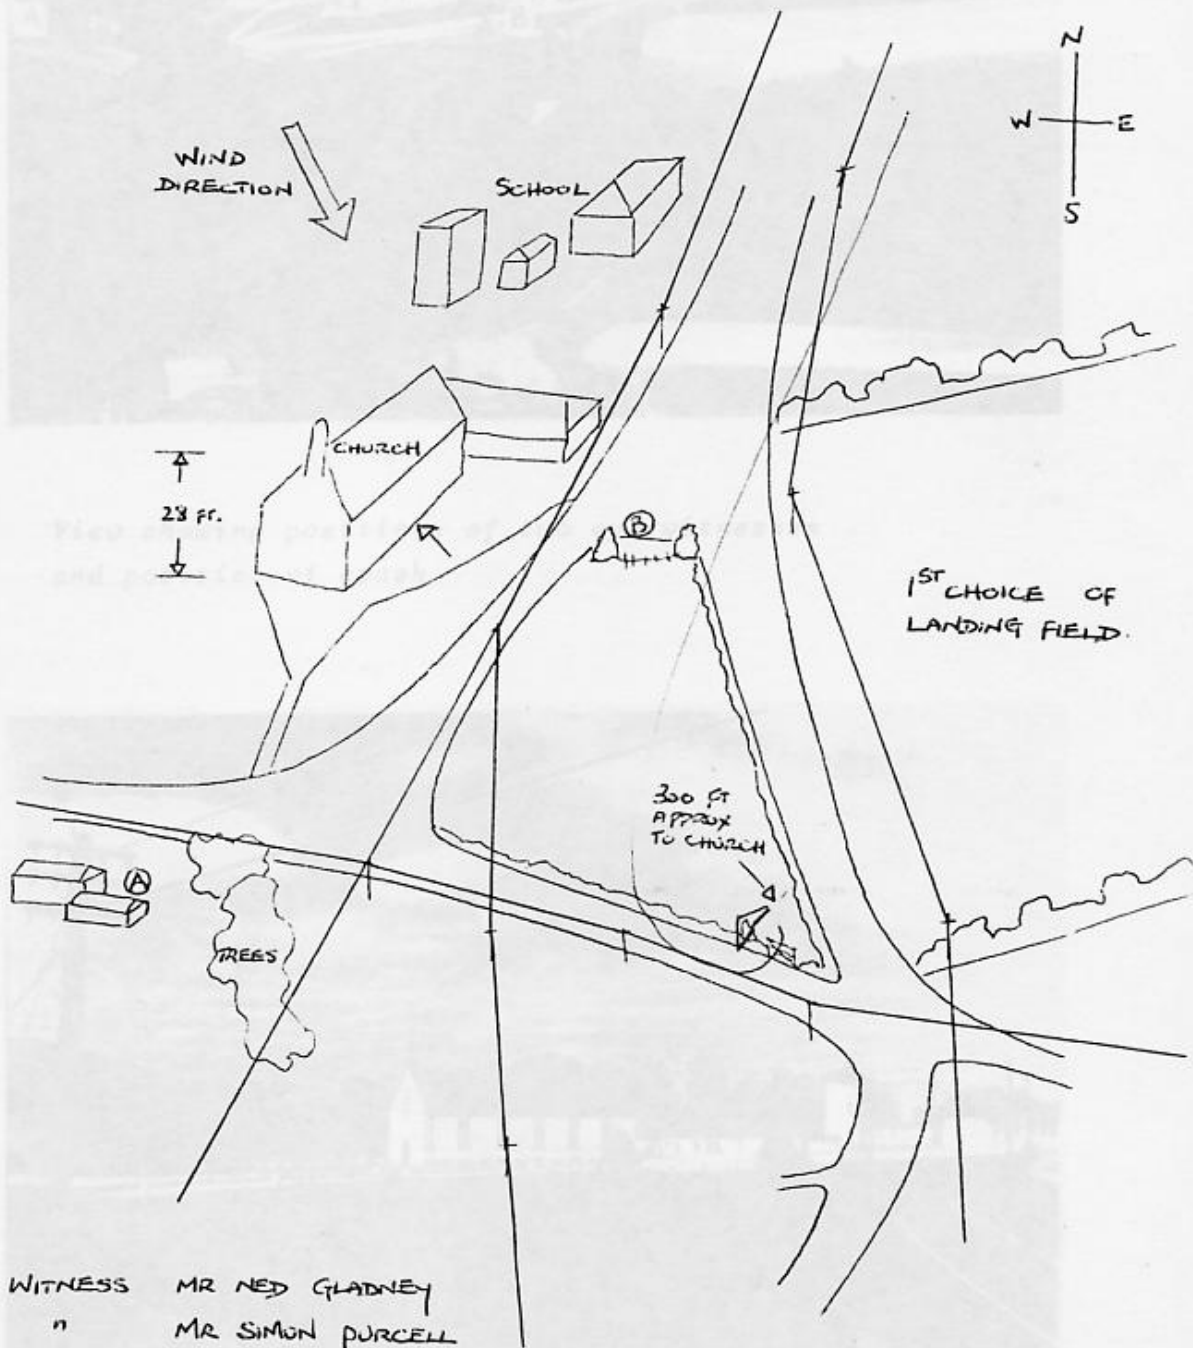
APPENDIX II

The field is triangular in shape and placed in a slight hollow in the surrounding countryside. It slopes slightly upwards to the North and is surrounded on all three (3) sides by tarred roads. Appendix II.

Their locations at the time of the accident as marked in Appendix II.

- Ⓐ WITNESS MR NED GLADNEY
- Ⓑ " MR SIMON PURCELL
- OVERHEAD WIRES.
- PAT'S FLIGHT PATH.
- △ POSITION OF CRASH.

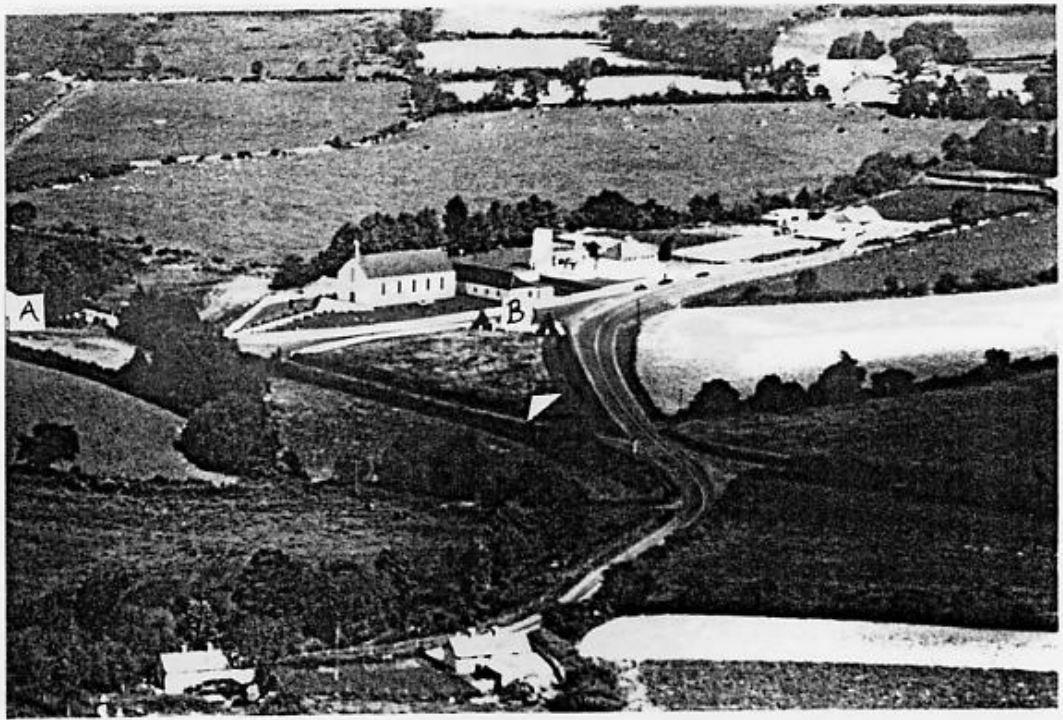
*View showing positions of two eye witnesses  
and position of crash.*

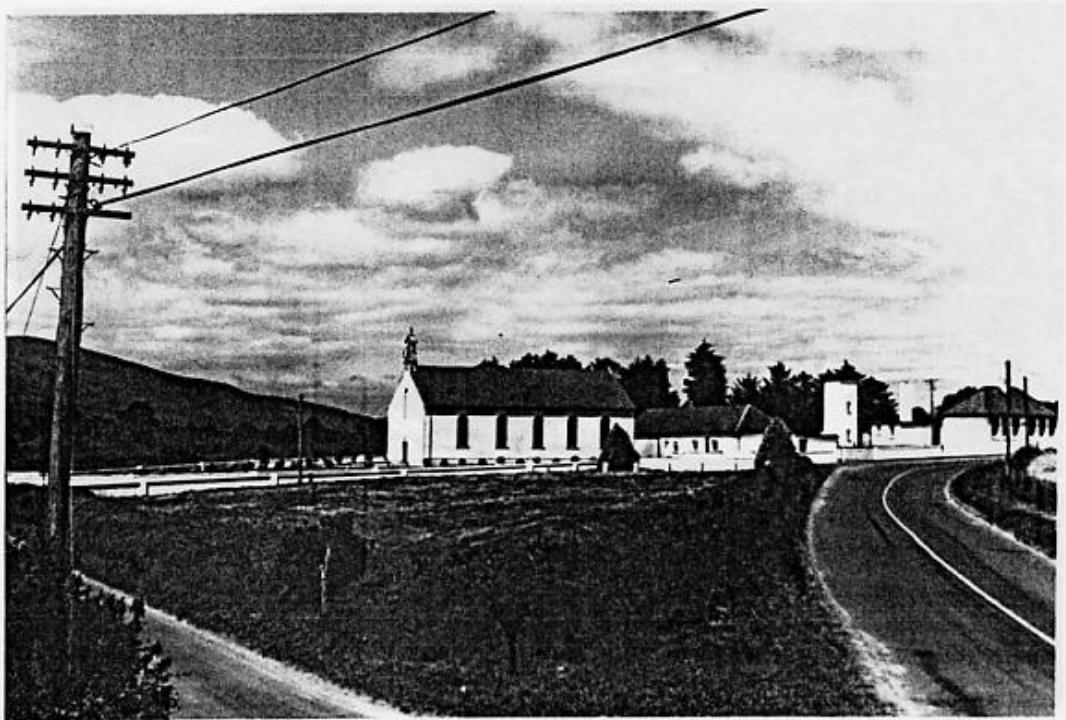
It seems most likely that Pat's accident was caused by him hitting a very severe rotor or wind shear at his final turning point when approaching his landing. As can be seen from the photographs and the diagram, Pat's turning point was down-wind from a church and school which must have caused severe turbulence.

*View north towards end of Bartolomeo road  
View into wind showing large obstructions  
up-wind of field.*

- LOCATION OF ACCIDENT
- 08 22 10 W
- (v) *Expect and prepare for turbulence if you are close to large obstacles.*
  - (vi) *Do not land directly down-wind of large obstacles.*
  - (vii) *If conditions are unstable or gusty, expect trouble close to the ground.*
  - (ix) *When landing in turbulent conditions, consider coming out of prone early to avoid injuries such as Pat's.*

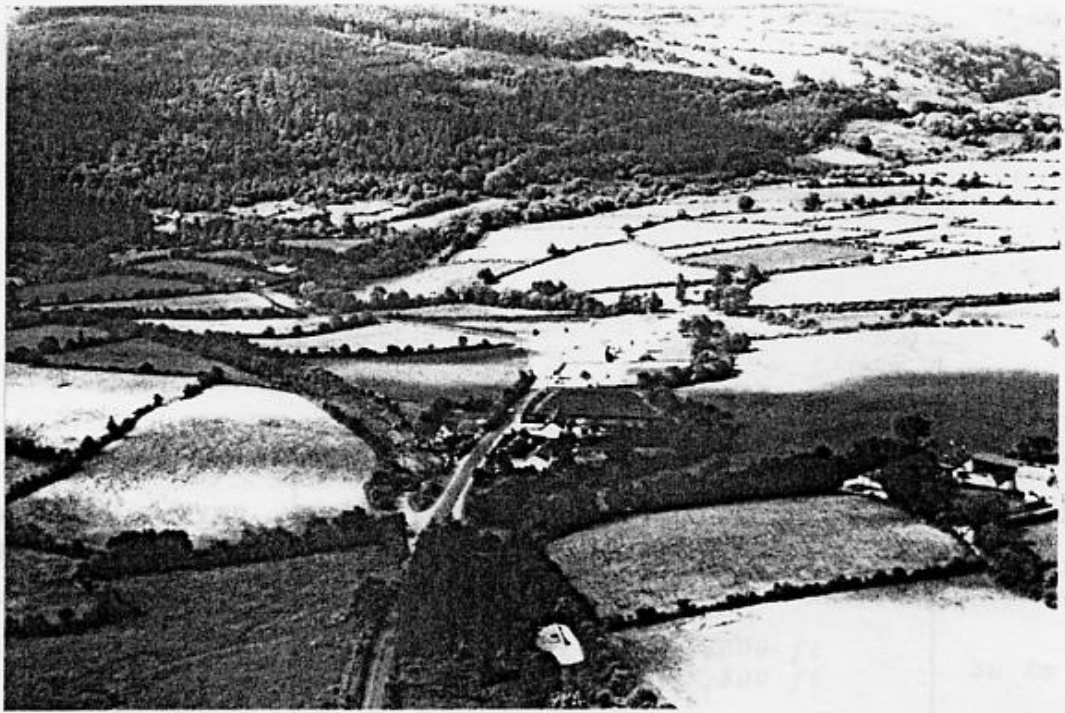
*Down-wind approach towards field.*

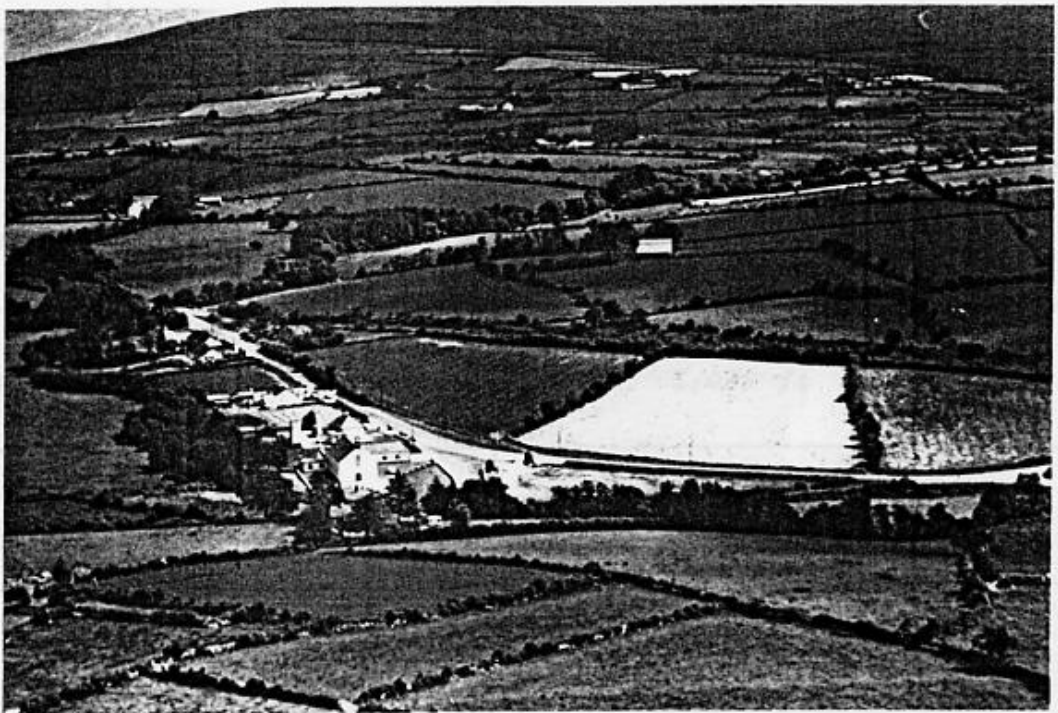
*View north towards end of Blackstairs and showing proposed landing field.*

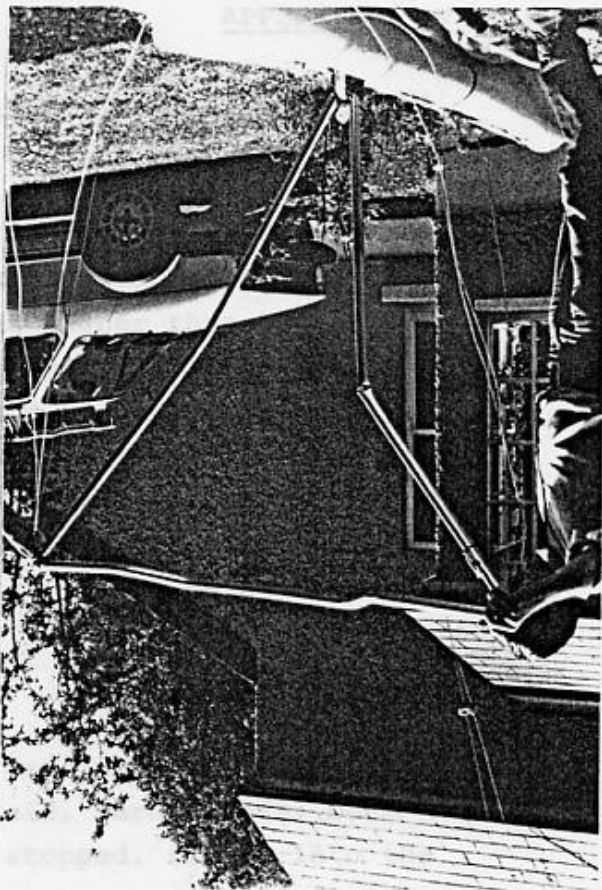
Broken inwards and slightly forwards. Bottom of upright bent and scored from bracket. Bottom bolt hole stretched and crazed.

Bent slightly forwards and inwards.

*Glider damage.*

*Suggested point of impact -*

*Right corner of A frame*

*(i.e. in holder's hand).*

*A frame folded inwards*

*and forwards.*

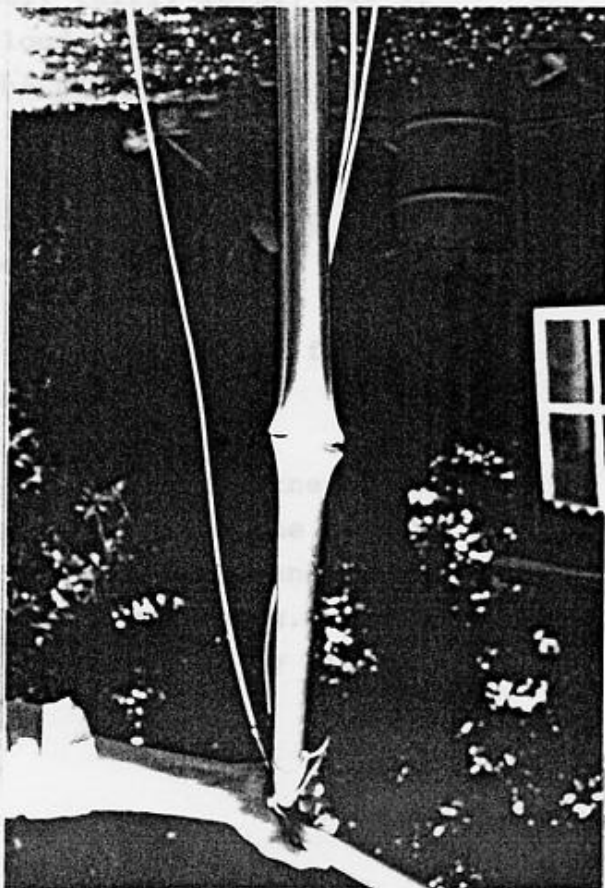
Badly buckled.

*Right upright broken  
inwards and forwards.*

*Bottom right hand upright  
bracket badly buckled under  
impact.*
